# Experience with Reinforced Plastic Primary Aircraft Structures

F. S. Snyder and R. E. Drake  
Piper Aircraft Corp.

Automotive Engineering Congress  
Detroit, Mich.  
Jan. 14-18, 1963

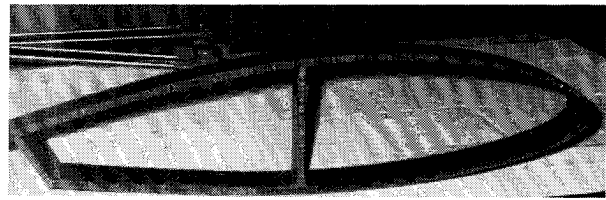
Fig. 3 - Cutaway section of outer wing

The basic wing structure was composed of the upper and lower skins running tip to tip. The skins carried the bending and torsion loads while the spar acted as a shear web and divided the buckling panels in half (Fig. 3). The inboard section of the spar structure performed other functions such as supplying the landing gear attachment. Inserts imbedded in the lower skin picked up aileron hinge brackets, jack pads, tie down fittings, and similar accessories.
